Manhole Inspection Summary

Manhole # S35EE1013MH

Insp Date: 1/31/07 11:34 AM

Location Address: **203 39TH ST**

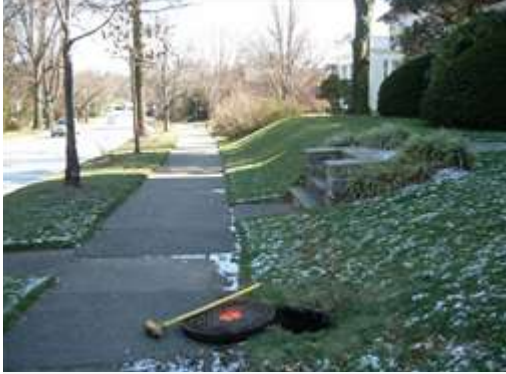
Location View

Comments **The MH's mapped location is incorrect.**

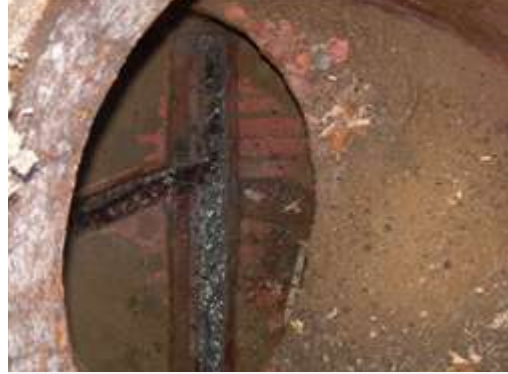
Top View

Bench debris. Channel debris(grease).

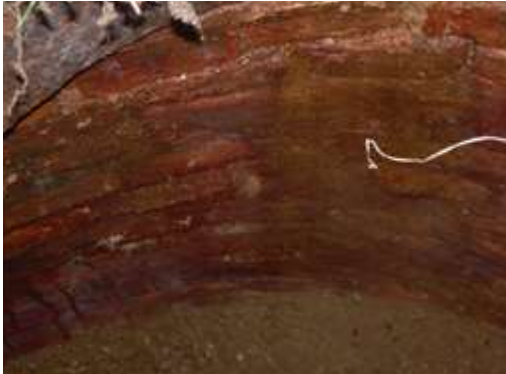
Defect

Frame Offset: **0** (in.) Condition: ☐ Sound ☐ Cracked ☒ **Leaks**

Corbel Material: **Brick** ☐ Parged Type: **Concentric/Eccentric**
Condition: ☒ Sound ☐ Cracked ☐ Root Intrusion ☐ Loose Brick ☐ Deteriorated
Infiltration: ☐ None ☒ **Joint** ☐ Cracks ☐ Mortar ☐ Roots ☒ **Wall**

Barrel Material: **Brick** ☐ Parged
Shape: **Circular** Diameter: **42** (in.) Length: (in.)
Condition: ☒ Sound ☐ Cracked ☐ Root Intrusion ☐ Loose Brick ☐ Deteriorated
Infiltration: ☐ None ☐ Joint ☐ Cracks ☐ Mortar ☐ Roots ☒ **Wall**

Frame leaks. Corbel and Barrel infiltration.

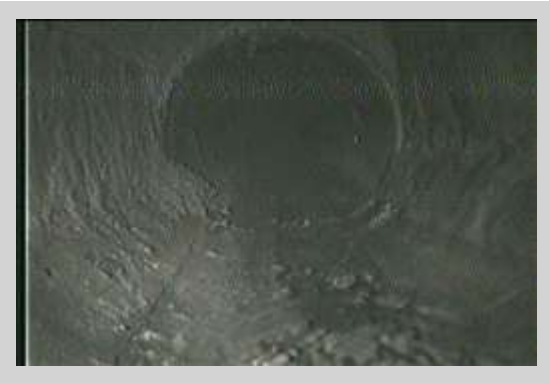
8 in. Circular Gravity Sewer Pipe Out @ 12 O'Clock

Pipe Material: **Clay** ☐ Pipe Lined

Invert Depth: **7.93** (ft.) Flow Characteristics: **Slow**

Infiltration: **None** Pipe Seal Cond: **Unknown**

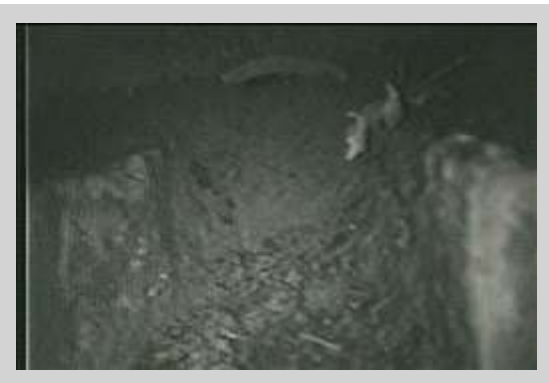
Pipe In @ 3 O'Clock

Pipe Material: **Unknown** ☐ Pipe Lined

Connects To: **Stub connection / abandoned**

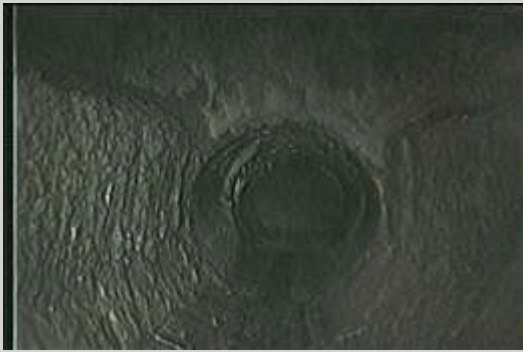
Pipe In @ 6 O'Clock

Pipe Material: **Clay** ☐ Pipe Lined

Invert Depth: **7.89** (ft.) Flow Characteristics: **Slow**

Connects To: **Dead End**

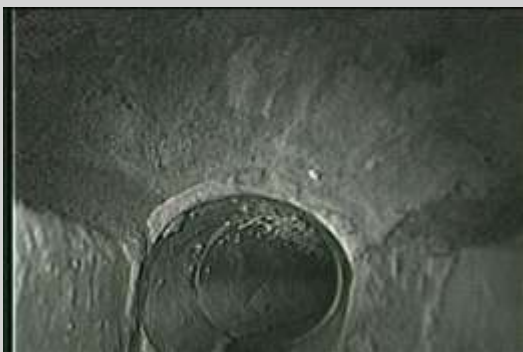
Pipe In @ 9 O'Clock

Pipe Material: **Clay** ☐ Pipe Lined

Invert Depth: **7.88** (ft.) Flow Characteristics: **None**

Connects To: **House connection / Service line**
